The *Normal* Hole

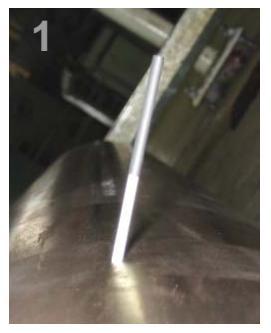
To show a transverse angle, it is often difficult to place any type of square or right angle within the picture to illustrate this. However, in this particular case (1), we can easily see the angle of our indicator. The Transverse Angle of this hole would nicely mimic a hook crack. One could place this type of hole for a test, however it is not practical to reproduce it consistently, or on a timely basis.

When ultrasonically tested, from either side of the weld, one would expect a hole with this transverse angle to produce a high level indication from one side and a low level indication from the other side, due to the geometry of the defect. This simply illustrates the need to test a weld from both sides.

Unfortunately the holes shown in pictures 1 and 2 above are one and the same! This 3.2mm through hole has both transverse and longitudinal angles. Not a consideration for Hydro-Testing, where a 'leaker' is just a hole, but a completely different 'animal' for a UT System. This particular hole was detected by the operator of the Hydro-Tester, however missed by the Final Inspection UT System. When the operator was told of this test, he examined the hole in the UT System again and viewed it both statically and dynamically. Weld alignment was not an issue, however when initially done, the first reaction was that the UT Test Head was not aligned to the weld.

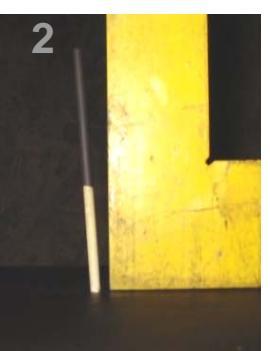
To illustrate the longitudinal angle (2), it is very easy to place a square within the picture. This angle, like a perpendicular hole, would illustrate a Penetrator or other type of Weld Interface defect. Again however, such a hole would be difficult to reproduce and would have little benefit. The 'trick' for drilling a hole, is to make it normal to the surface of the pipe.

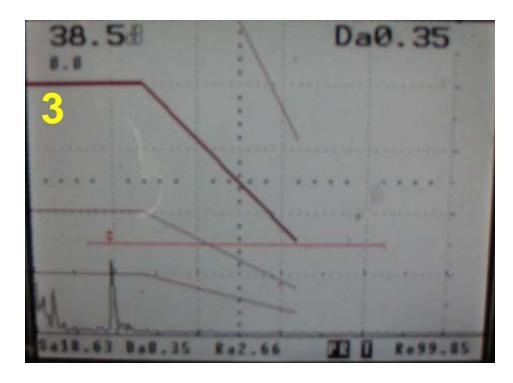
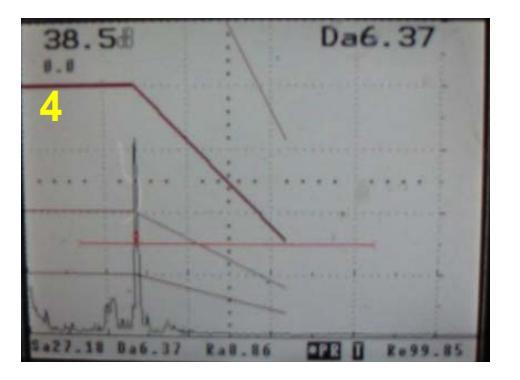
The A-Scan marked 3 shows a low level indication produced from the left side of the indication in picture 1. While A-Scan 4, shows a higher level indication produced from the right side of picture 1. If the extra 6dB of gain were removed, the indication in picture 3 would be 50% lower, and the same holds true for A-Scan 4. This reduction in sensitivity would make the indications below a Reject level.

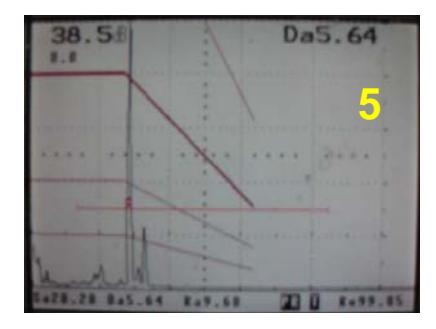
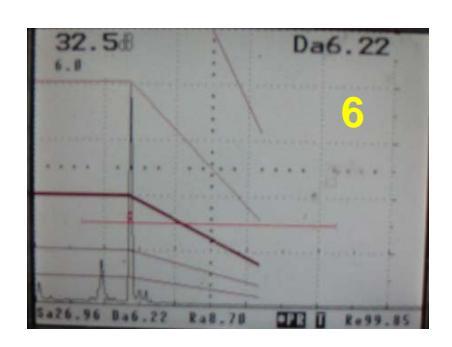
For Comparison, A-Scan 5 shows a manual standardization on 3.2mm hole, Normal to the surface, with the 6dB of Gain Added. A-Scan 6 shows the same hole, with the 6dB removed.

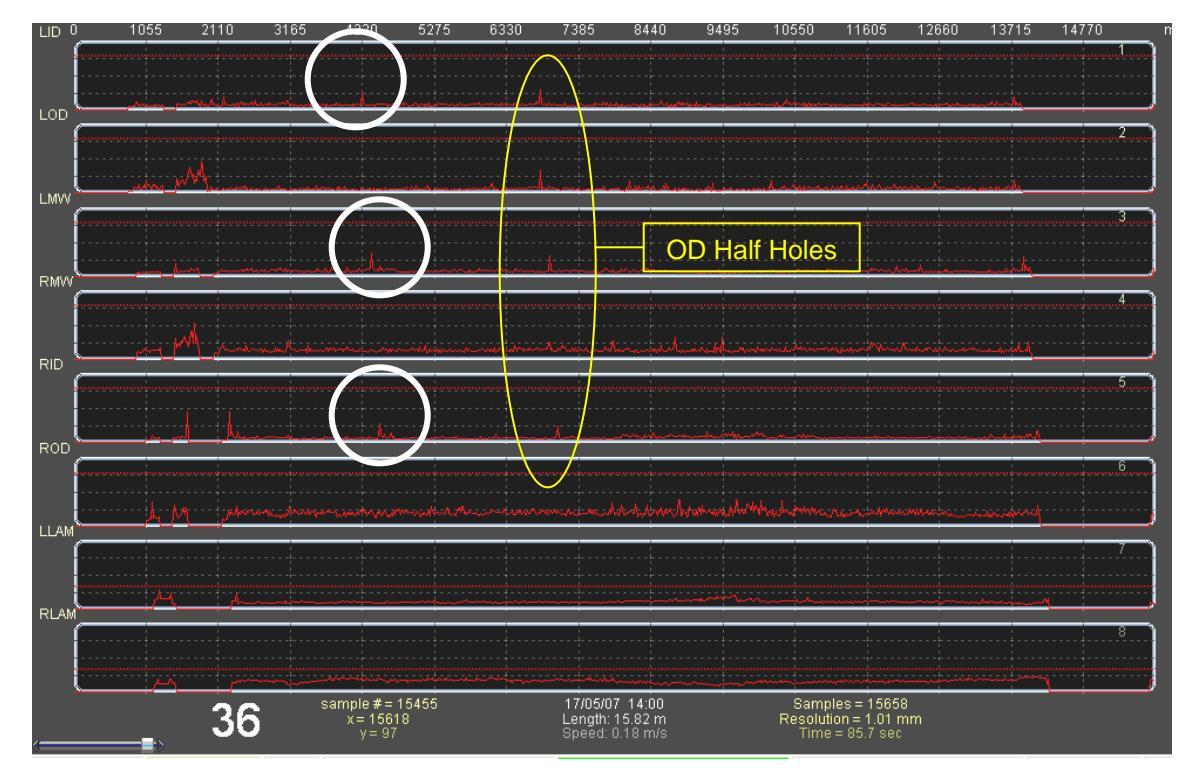
We can see that only our Left Channels show an indication, however they are all well below the reject threshold of 80% of the full screen height. The OD Half Hole has produced a higher indication on the OD channels, which is due to 2 factors; the extra reflective area of the Apex; and the compound angle (transverse and longitudinal) was not as great.

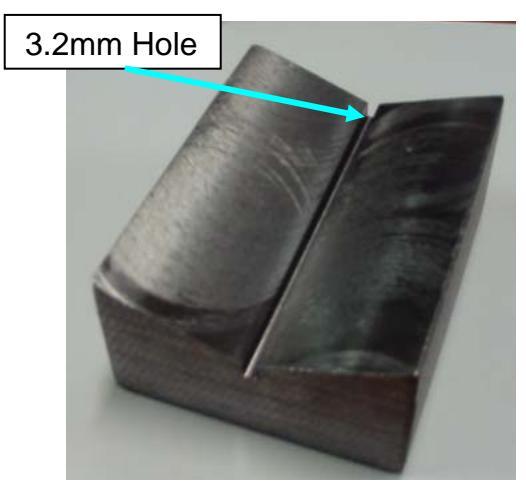
These Holes were simply manually drilled, or "Hand Bombed" as this author refers to them. Obviously, such holes are of little use for checking UT machines, as it is next to impossible to make them normal to the surface. When holes are used for a calibration standard, they are machined by a skilled technician. So what is the 'trick' to making these manually drilled holes quickly, easily, and above all, reproducibly? This drilling requires a basic fixture, which is a V-Block, with a hole drilled thought he Apex of the V. When used with a very sharp or new drill bit, and a variable speed drill, a reference hole can be reasonably reproduced. The author has also trained Mill-Line UT Operators to use these fixtures to verify the effectiveness of their Mill-Line Equipment. While not encouraged, a Mill-Line UT system can be effectively calibrated (standardized) with such holes. Furthermore, with slightly more skill, and the use of a Dial Indicator Pit Gauge, an operator can make Flat Bottom Holes quickly and reliably.
