Calibration Standards for High Performance Tubes & Pipes

By Mark B. Palynchuk, Western Instruments Inc.

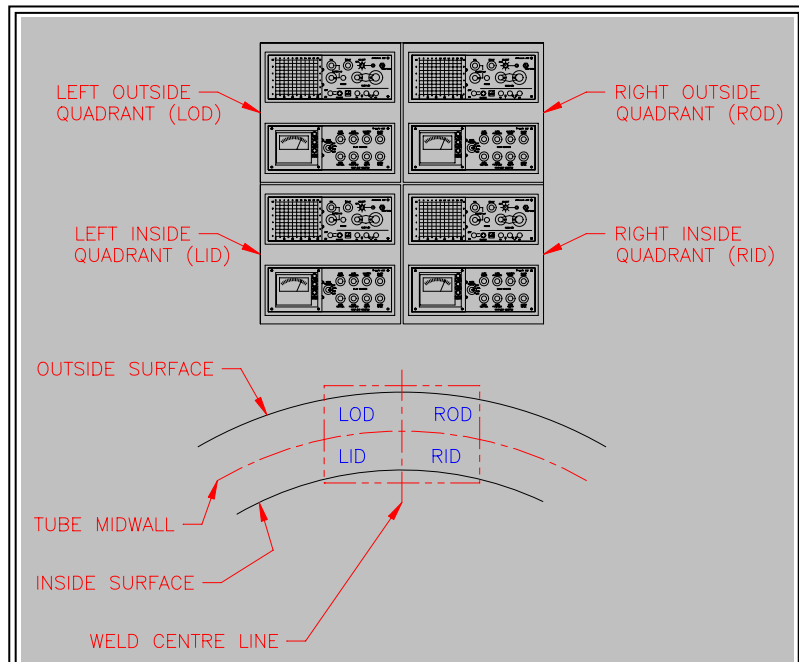
Figure 1: Sensitivity zones to address OD/ID and LEFT/RIGHT defect geometry.

In the early years of ultrasonic testing for weld defects, notches were used as artificial defects, because of their previous use as in manual testing, in part because large transducer elements were being used, obviously at low speeds. Notches provided a means of aligning the transducer with respect to the longitudinal axis of the tube and in turn the weld. First multi-channel weld testers were developed to deal with geometric characteristics of defects. [See Figure 1]

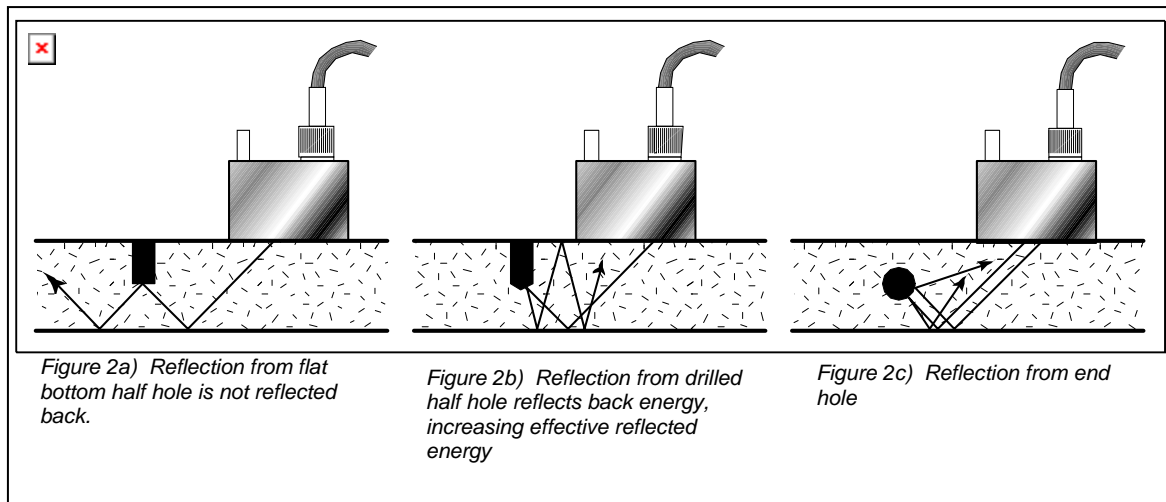
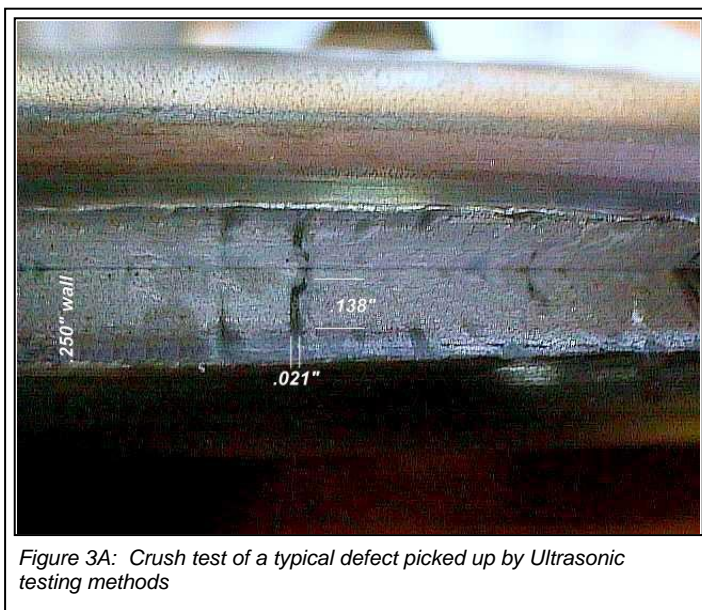
calibrations standards ensuring both probes could identify half holes on the opposite side. [See Figure 2a) 2b) 2c) and Figure 3]

Half holes ensure mid-wall sensitivity when using multi-channel units on heavier wall thickness'. As mentioned previously, holes represent short defects and small reflective area defects. It is important for half holes to be flat bottom and illustration 2b) shows the reason for this.

An alternate method for checking the alignment of the probe with respect to the axis of the pipe is the use of a hole drilled into the end of a calibration standard, (Figure 2c) as has been previously discussed, for checking on the sensitivity to mid-wall defects because this also provides a very large reflector similar to a notch. Again, these are relatively easy and inexpensive to produce as compared to good quality notches.

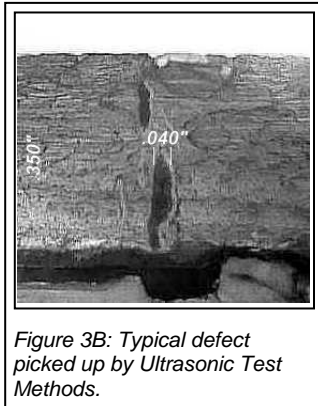
Figure 3B: Typical defect picked up by Ultrasonic Test Methods.

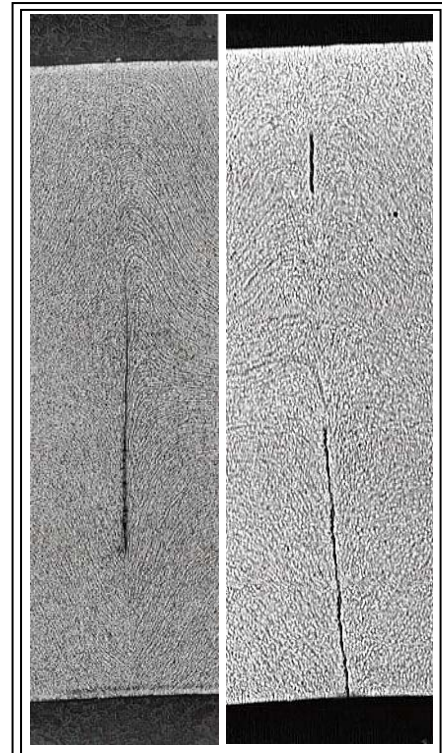
Figure 3c) [Left]: Photomicrograph of a defect picked up by Ultrasonic testing. Figure 3d) [Right]: Photomicrograph of a defect picked using ultrasonic testing.

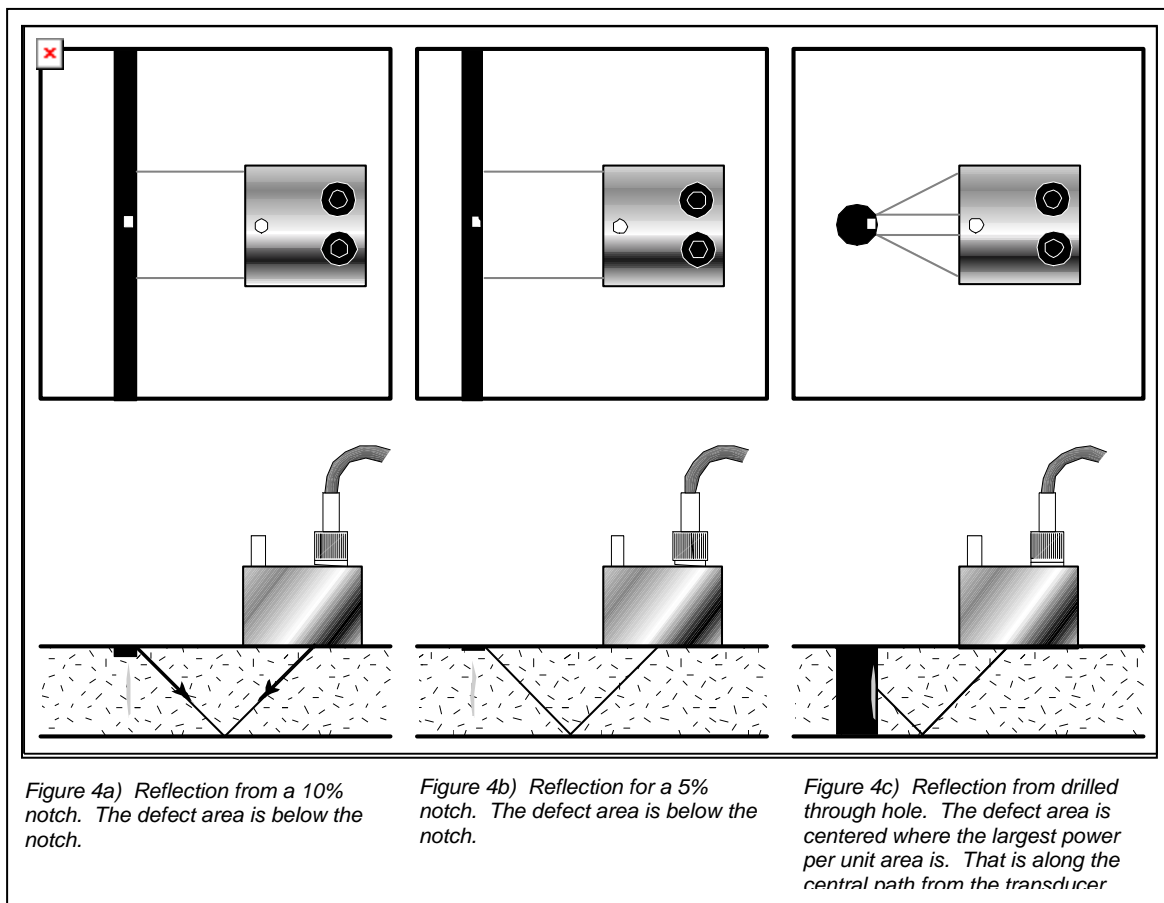
Holes as can be seen in the Figures 2a) to 2c) are far more representative of short, small defects. The actual reflective area is not the diameter of the hole, but is a fraction of it as is illustrated in the Figures 4a) and 4b). Holes are relatively inexpensive to reproduce and the procedures for doing these are well established.

As shown in the previous part of this paper, the actual reflecting area of a hole as an artificial defect is not the diameter of the hole, but is very much reduced as can be seen from the graphical representation of an ultrasound beam interacting with a hole and a notch. Reflection from the hole is illustrated as shown in Figure 4c).

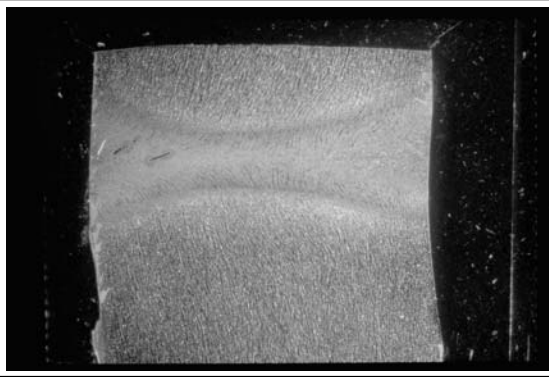
Figure 5a): Micro of small hook cracks near weld interface similar to a weld line defect.

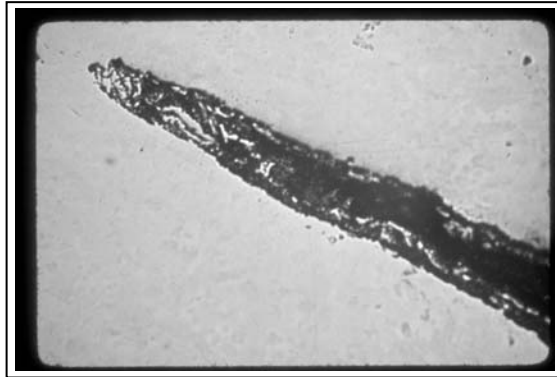
Figure 5b): SEM of tip of crack in 5a) Magnification 67X

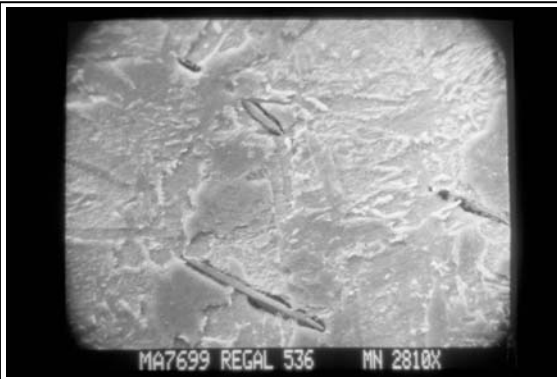
Figure 5c): SEM of 5a) Magnification 2,810X

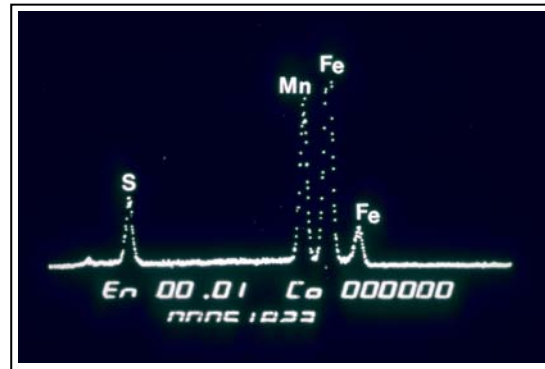
Figure 5d): SEM of Figure 5a) X-Ray spectrum
